Manhole Inspection Summary

Manhole # S13II1034MH

Insp Date: **1/17/07 10:30 AM**

Location Address: **2501 COLD SPRING LN**

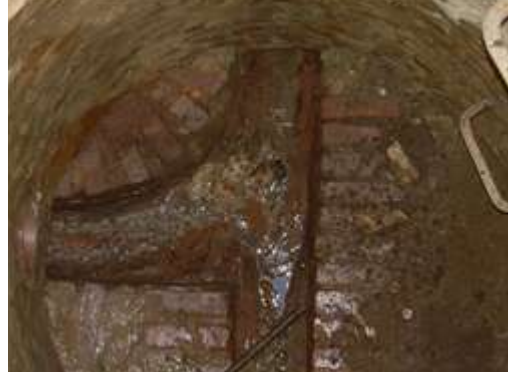
Top View

Evidence of surcharge - Bench debris.
Channel debris.

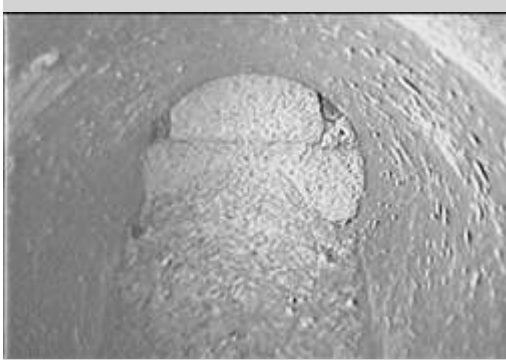
Inside the I6

Plugged.

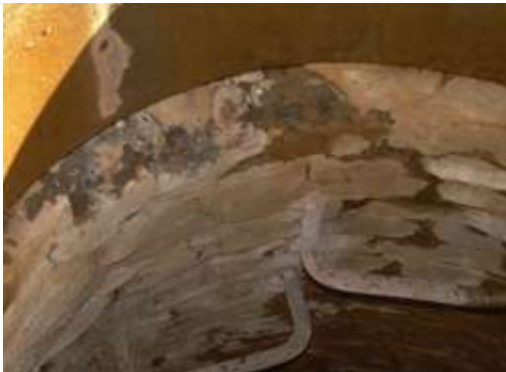
Defect

Frame Offset: **1** (in.) Condition: ☐ Sound ☐ Cracked ☒ **Leaks**

Condition: ☐ Sound ☐ Cracked ☐ Root Intrusion ☐ Loose Brick ☒ **Deteriorated**

Infiltration: ☐ None ☒ **Joint** ☐ Cracks ☒ **Mortar** ☐ Roots ☐ Wall

Frame leaks. Adjustment deterioration
and infiltration. Corbel and Barrel
infiltration.

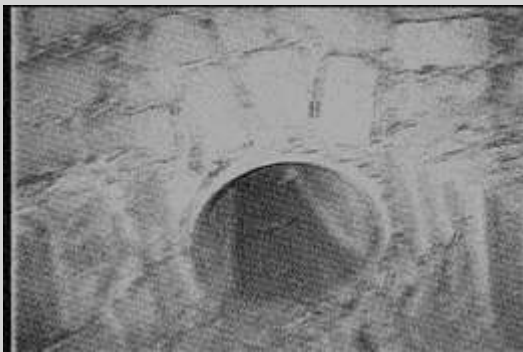
8 in. Circular Gravity Sewer Pipe Out @ 12 O'Clock

Deposits: ☐ None ☐ Mud ☐ Sludge ☐ Debris ☒ Grease

Infiltration: **None** Pipe Seal Cond: **Cracked**

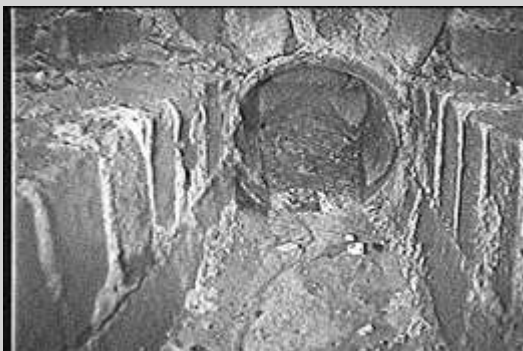
8 in. Circular Gravity Sewer Pipe In @ 6 O'Clock

Deposits: ☐ None ☐ Mud ☐ Sludge ☒ Debris ☐ Grease

Infiltration: **Evidence** Pipe Seal Cond: **Cracked**

Connects To: **Stub connection / abandoned**

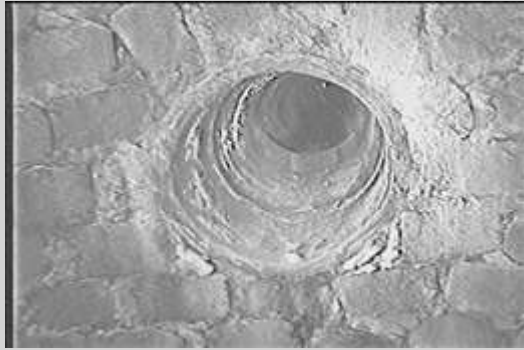
Pipe In @ 9 O'Clock

Infiltration: **Evidence**

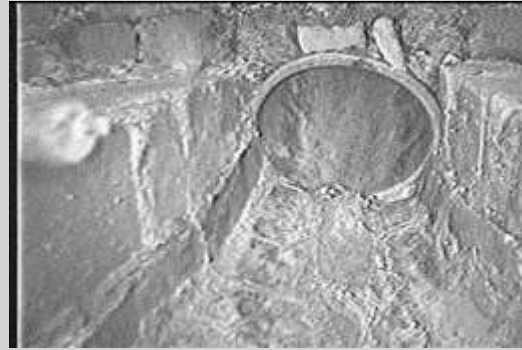
Drop In @ 9 O'Clock

Drop: **Outside** Rod and Bar

Drop Condition: **Open**
